Compost Made Handy

Testing report on 2kg machine

DATE: August 26 to September 29, 2009

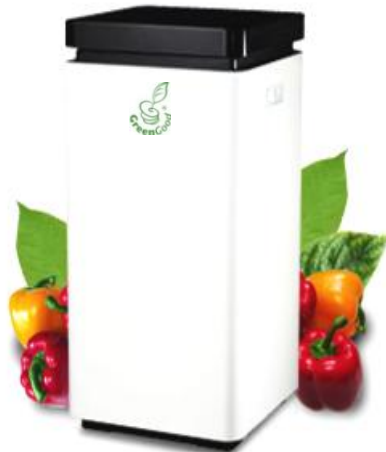
PRODUCT PHOTO:

Product Name:	Residential Machine (4.4lbs / 2kg)
Model Number:	GG-CMO-02
Dimensions:	20.87" (w) x 17.72" (l) x 30.71" (h) or 53 (w) x 45 (l) x 78 (h) cm
Power Consumption:	60kWh/month
Waste Treatment Capacity:	4.4lbs/day or 2kg /day
Target Market:	Family

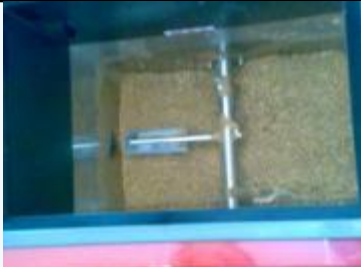
Time	Log details	Photos
1000	2 bags of saw dust being poured into the machine and run for 3 hours for start up process to wake the micro-organisms

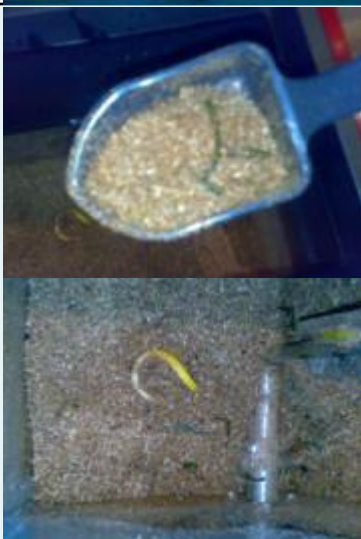
1900	Most of the food has been decomposed. Only small amount of vegetables and lemon peels remain inside the tank

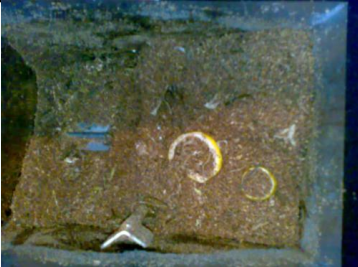
Time	Log details	Photos
0900	Most of the food has been decomposed. Only small amount of vegetables and lemon peels remain inside the tank

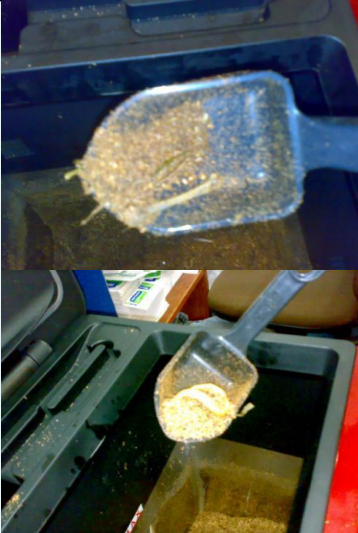
1900	Again, most of the food has been decomposed. Only small amount of vegetables, bones and lemon peels remain inside the tank

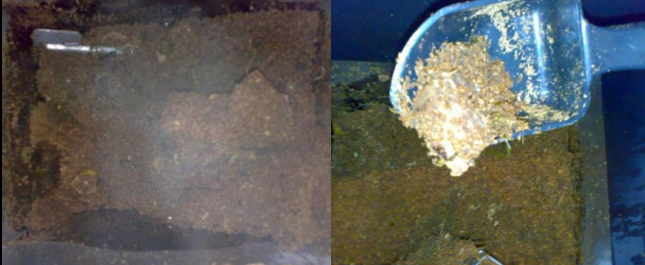
1800	Most of the foodwaste has been composted, only small bones remain in the tank

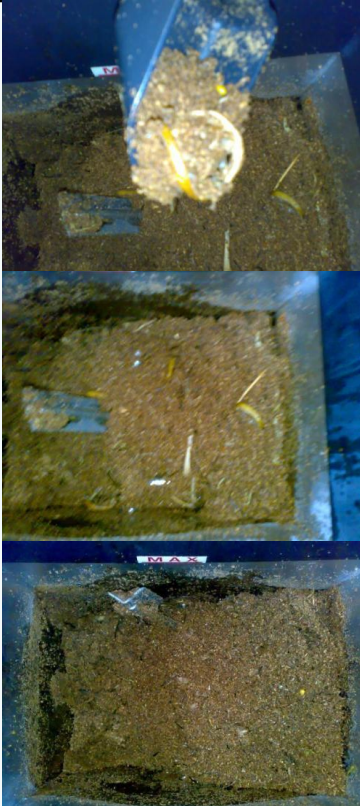
Time	Log details	Photos
0900	Most of the food has been decomposed. But the lemon peels remain inside the tank

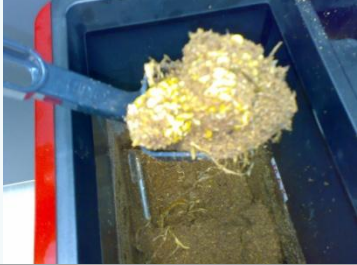
Time	Log details	Photos
0900	The carrot, corn, raw pork and small bones still remain inside the tank, but in a much smaller size, which means they have been composted a little bit

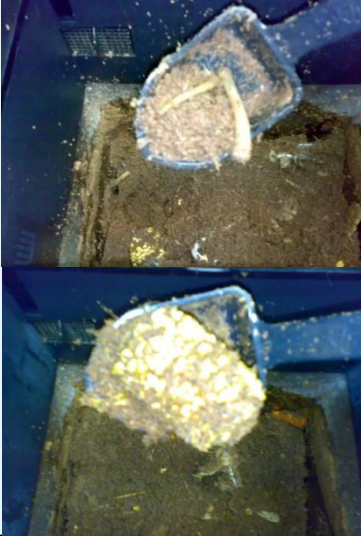
1700	The carrot, corn, raw pork and small bones still remain inside the tank, but in a much smaller size

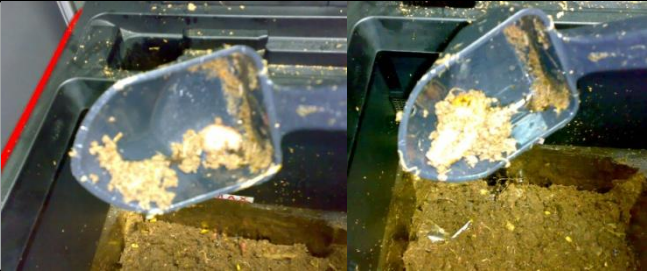
Time	Log details	Photos
0900	PSM fork, corn and carrot remain inside the tank The PSM fork stays in the same size, corn and carrot have reduced in size during the composting process

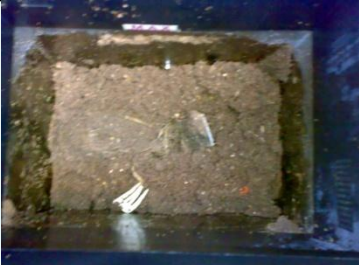
1800	PSM fork, corn and carrot remain inside the tank The PSM fork stays in the same size, corn and carrot have reduced much during the composting process

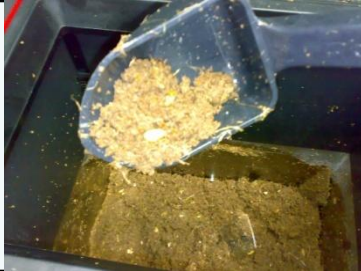
Time	Log details	Photos
0900	PSM fork, corn and bones remain inside the tank The PSM fork stays in the same size

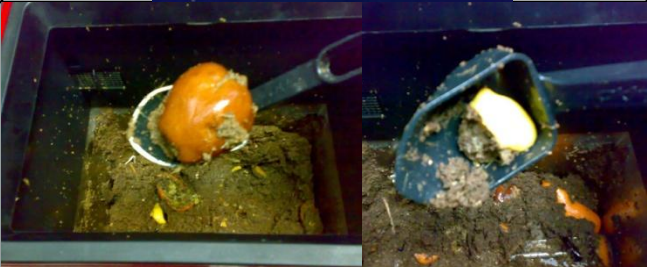
1800	PSM fork, apple, orange peels still remain inside the tank. The rest of the items have been composted within 4 hours

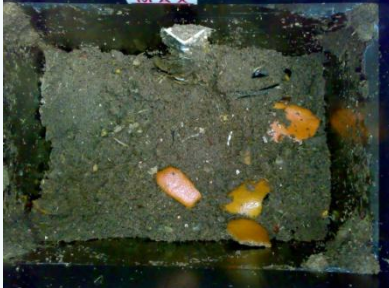
Time	Log details	Photos
0900	Most of the food has been decomposed. But the PSM fork, apple, orange peels still remain inside the tank

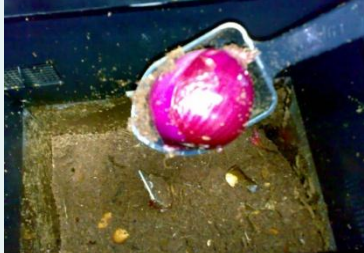
1800	The onion still stays in shape after 4 hours of composting process

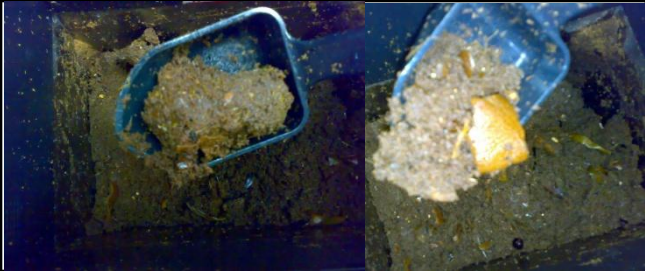
Time	Log details	Photos
0900	PSM fork, tropical fruit seeds mango seeds and orange peels are still inside the tank. However, they all have reduced in size

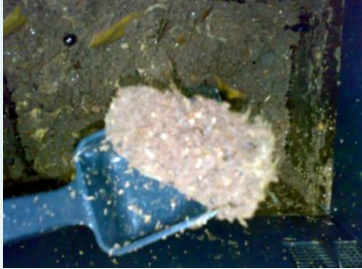
1800	Most of the food has been composted. PSM fork tropical fruit seeds mango seeds, peanuts and orange peels are still inside the tank. The lunch box in bagasse material has disappeared

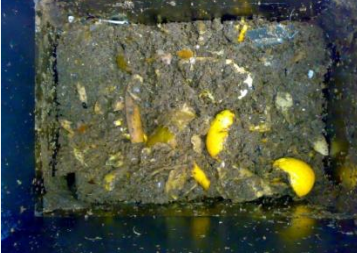
1800	PSM fork tropical fruit seeds mango seeds, peanuts and orange peels are still inside the tank. But they all reduced in size

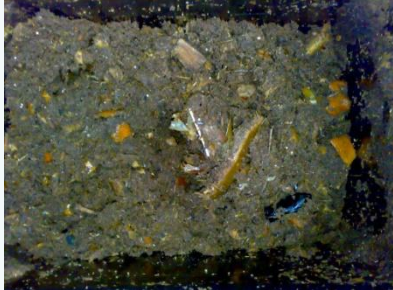
Time	Log details	Photos
0900	Most of the food has been decomposed. But the PSM fork tropical fruit seeds mango seeds, peanuts and orange peels are still inside the tank. But they all reduced in size

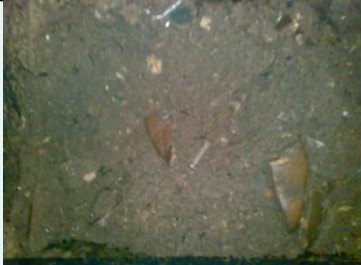
1800	orange peels stay in the inside the tank but reduce in size.

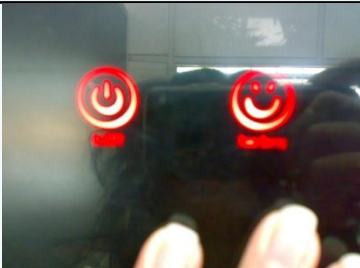
Log details	Photos
0900	Machine has turned to power saving mode

The machine itself will automatically turn to power saving mode and stop mixing the compost when the humidity inside the tank drops under a certain level. In such case, water needs to be added in order to make the machine run again and continue the composting process. However, when you input the foodwaste into the machine on a daily basis, there is water content inside the foodwaste (either soup, sauce or moisture comes from the food). We do not have to input water into the machine unless the foodwaste is too dry itself.

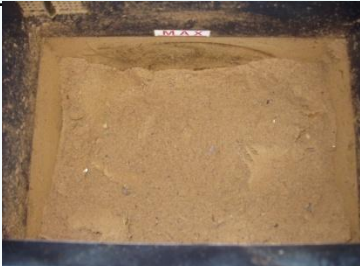
Log details	Photos	
0900	Machine has turned to power saving mode. The compost is dry and in reddish brown color

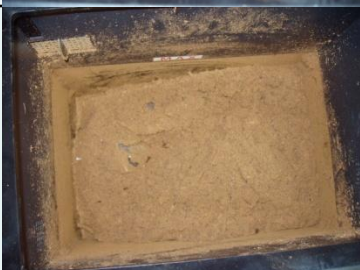
1800	The mango seeds and some fruit peels are still inside the tank and they look dehydrated

- large bones, though they reduce in size quite abit
- fruit seeds, the outer shell of the seed is hard for the micro-organisms to break in
